FLAGLER COUNTY PROVIDED PHOTOS OF ROTTEN WOOD AREAS

TTV ARCHITECTS PROVIDED CONSTRUCTION PHOTOS OF ROTTEN WOOD AREAS

TTV ARCHITECTS PROVIDED CONSTRUCTION PHOTOS OF AREAS DRILLED DURING CONSTRUCTION VISIT (7.2.15)

GENERAL CONTRACTOR PROVIDED PHOTOS OF ROTTEN WOOD REPAIRED AREAS (7.7.15)

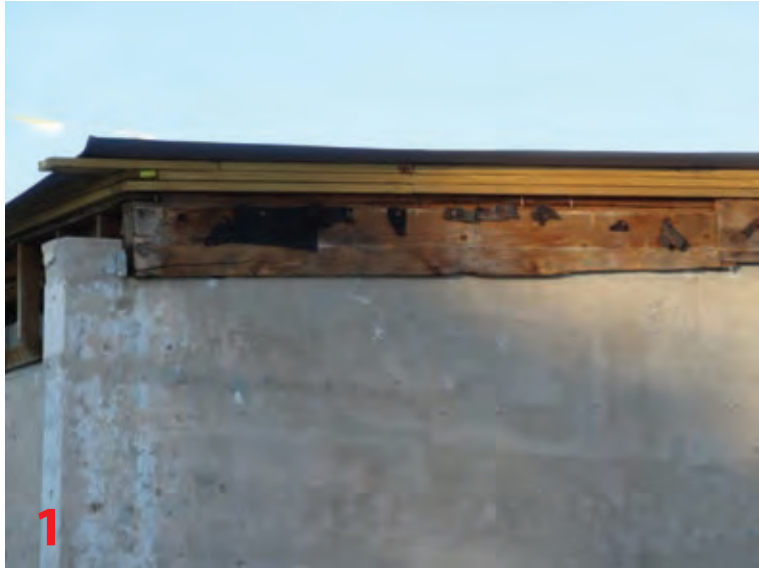
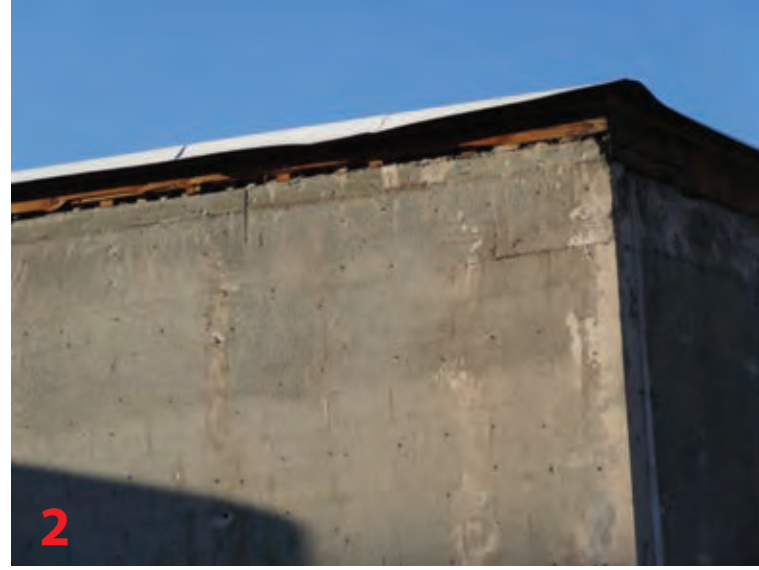
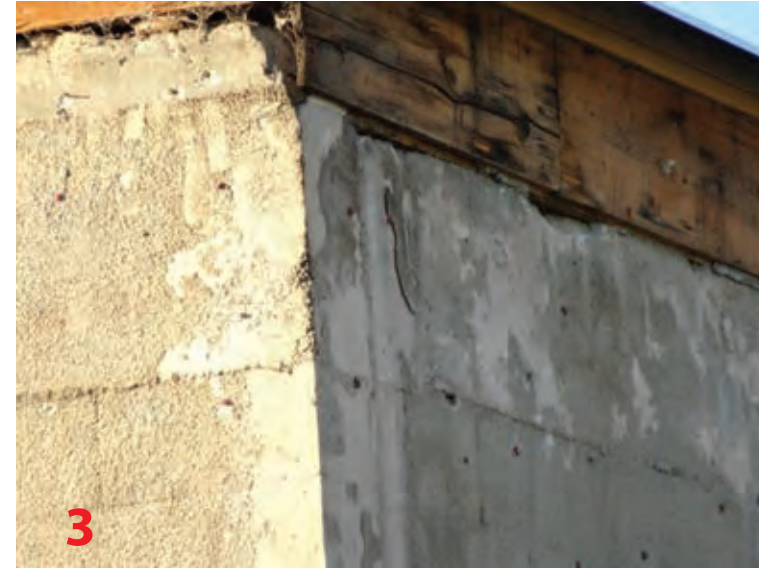
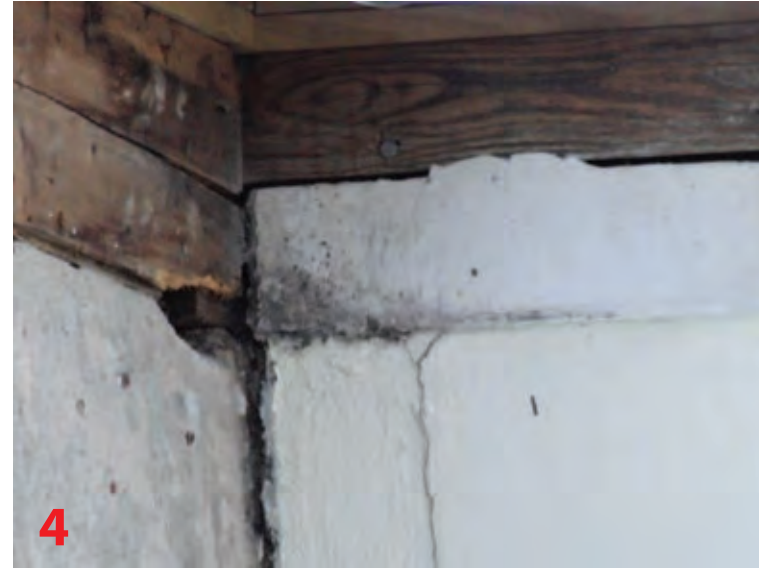
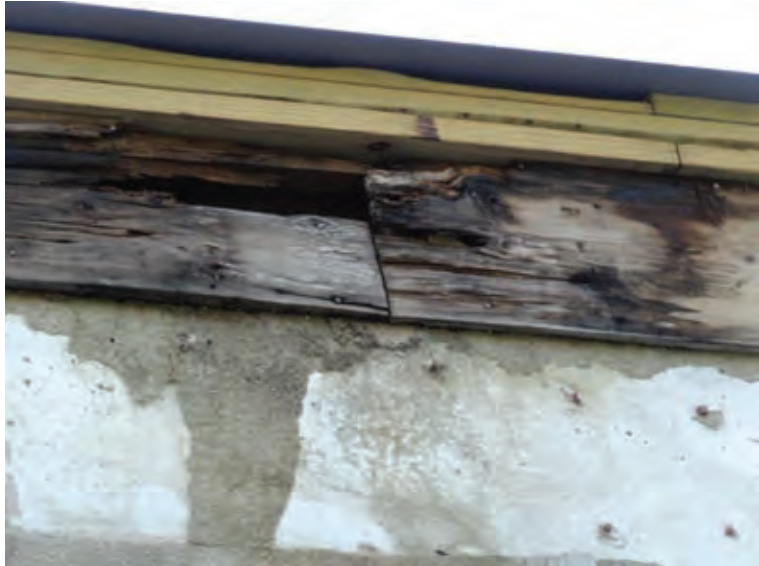
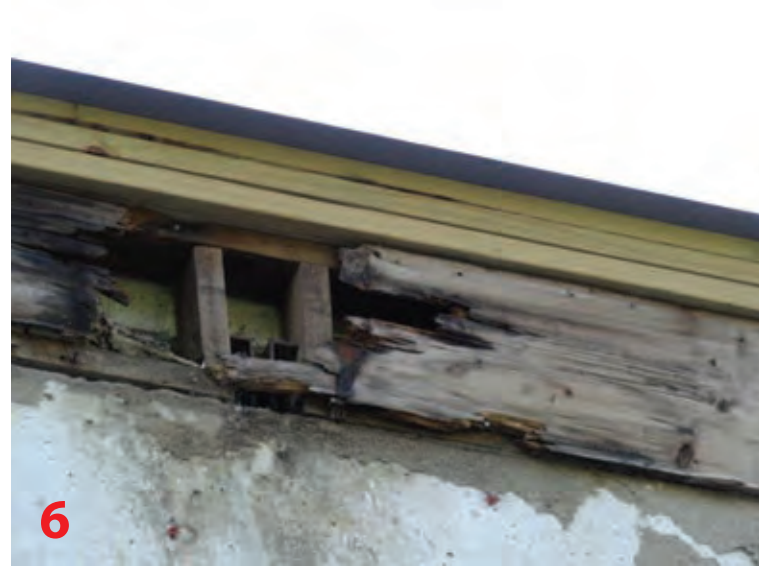
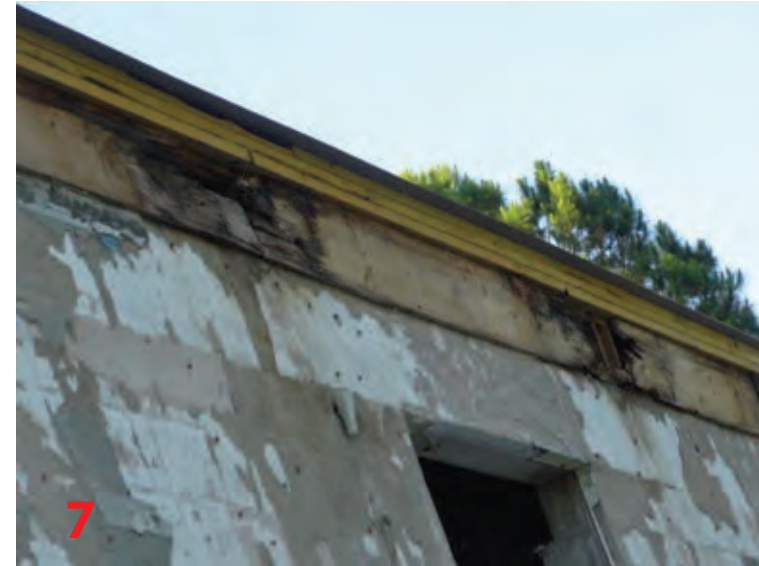
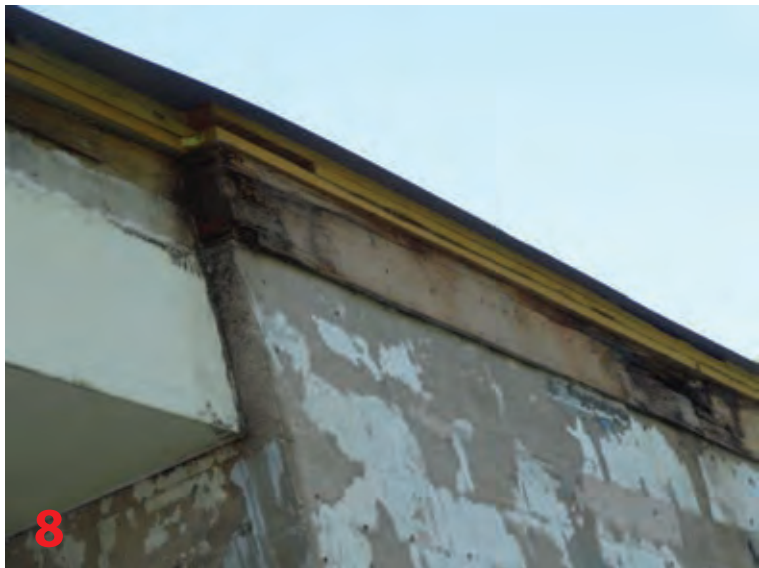
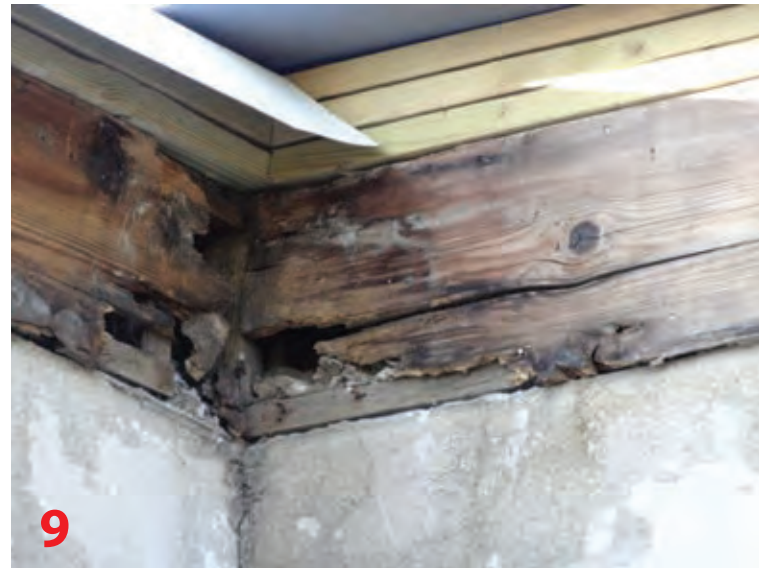
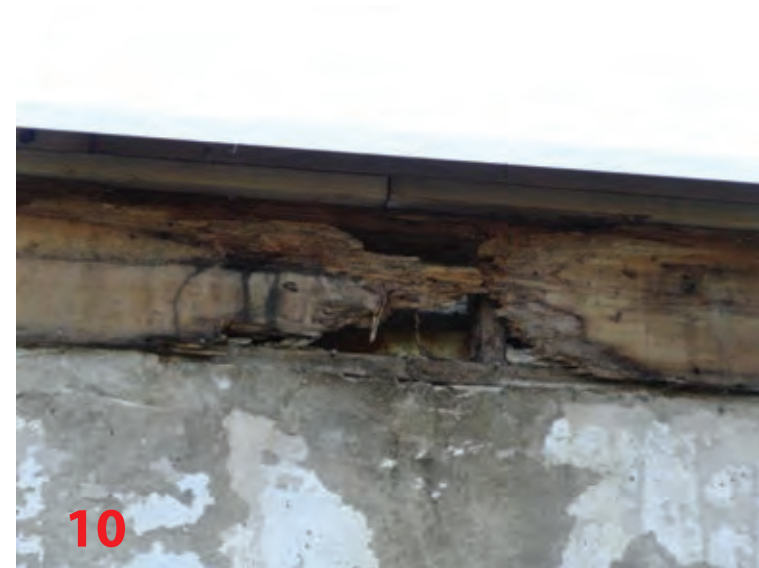
Based on the photos in the email, different conditions of the rotten fascia board are shown. However without seeing more of the context in the photos it is difficult to tell exactly what area is being photographed. However, During the initial construction meeting the Architect team and General Contractor walked the site and had observed various areas of rotten wood near the roof which were previously inaccessible. There was a change order approved to remove/replace the uncovered rotten wood fascias and provide new roof tie downs. The structural engineer reviewed the condition on-site and provided additional structural drawings for this portion of replacement work so ultimately this facility will meet or exceed current Florida Building Code requirements. Speaking with the General Contractor this morning, there are still areas of rotten wood to be replaced and are in the construction schedule to be completed. Once this work occurs, the new roof will be tied into the vertical wall, metal flashings installed along with new metal gutter assembly, all of which will provide for a watertight condition, again meeting the Florida Building Code wind pressures based upon the 140mph Ultimate Wind Speed for this specific project location.. To our knowledge we are not aware of any subpar standards in the construction process and observers need to keep in mind that construction is a process that takes time to complete.

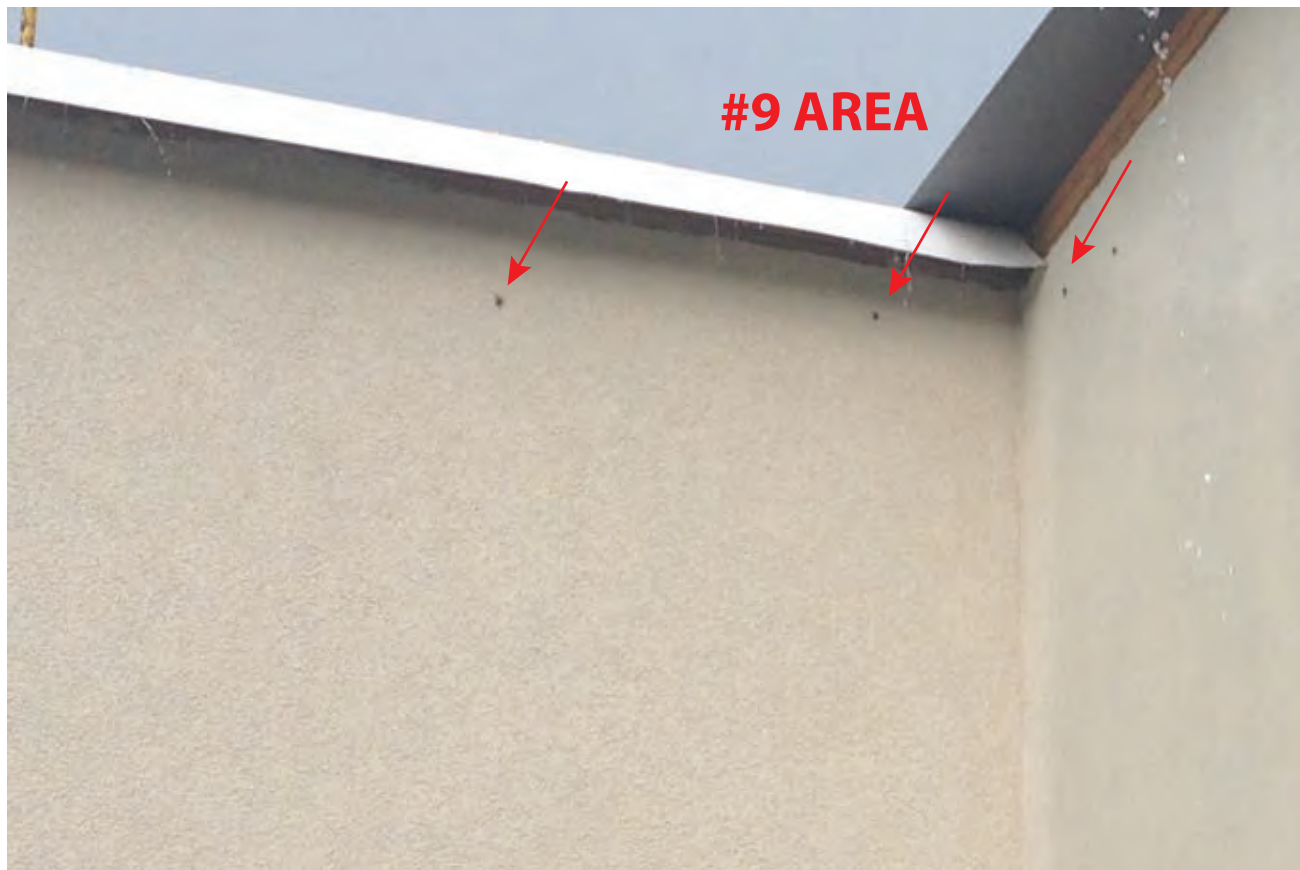
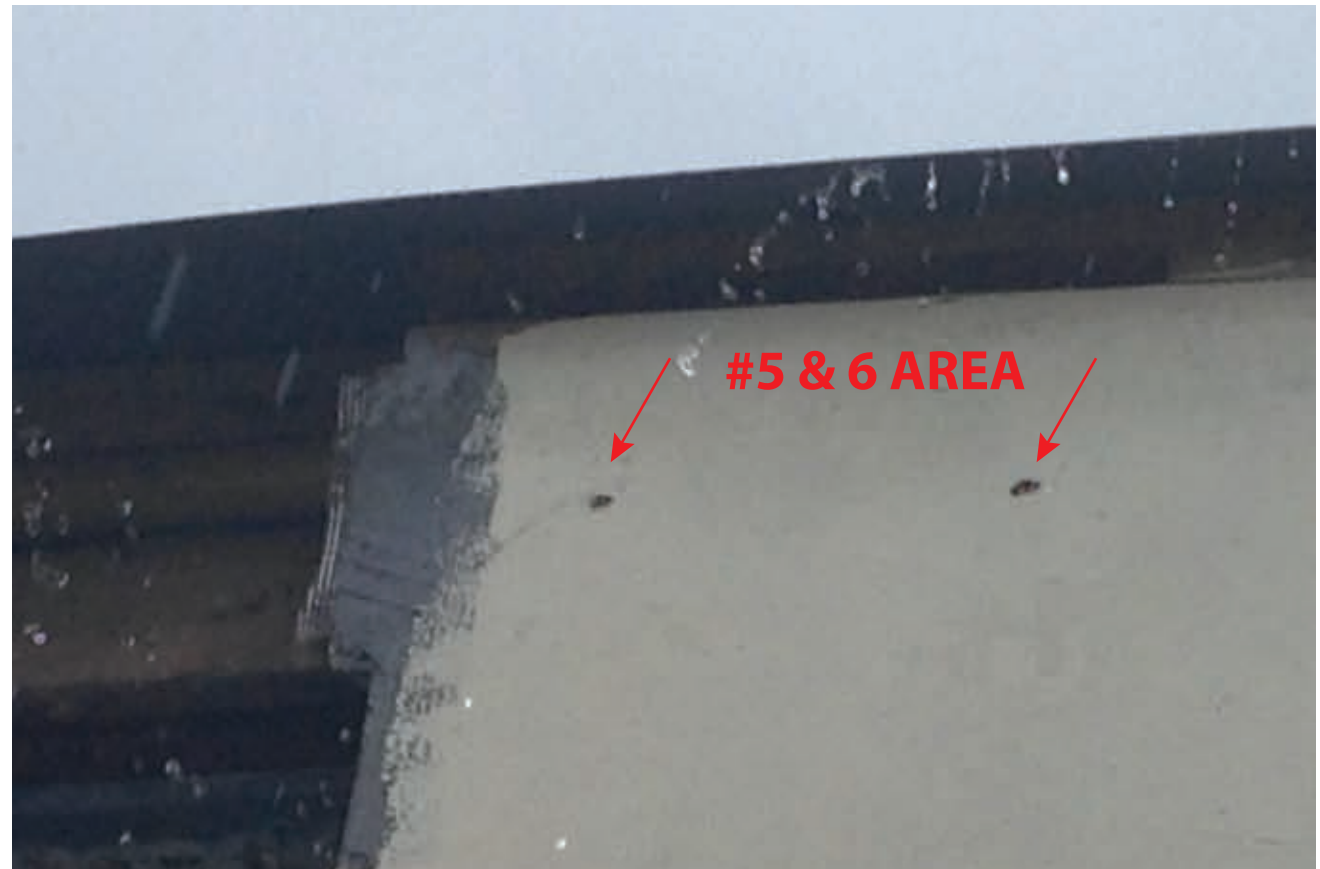
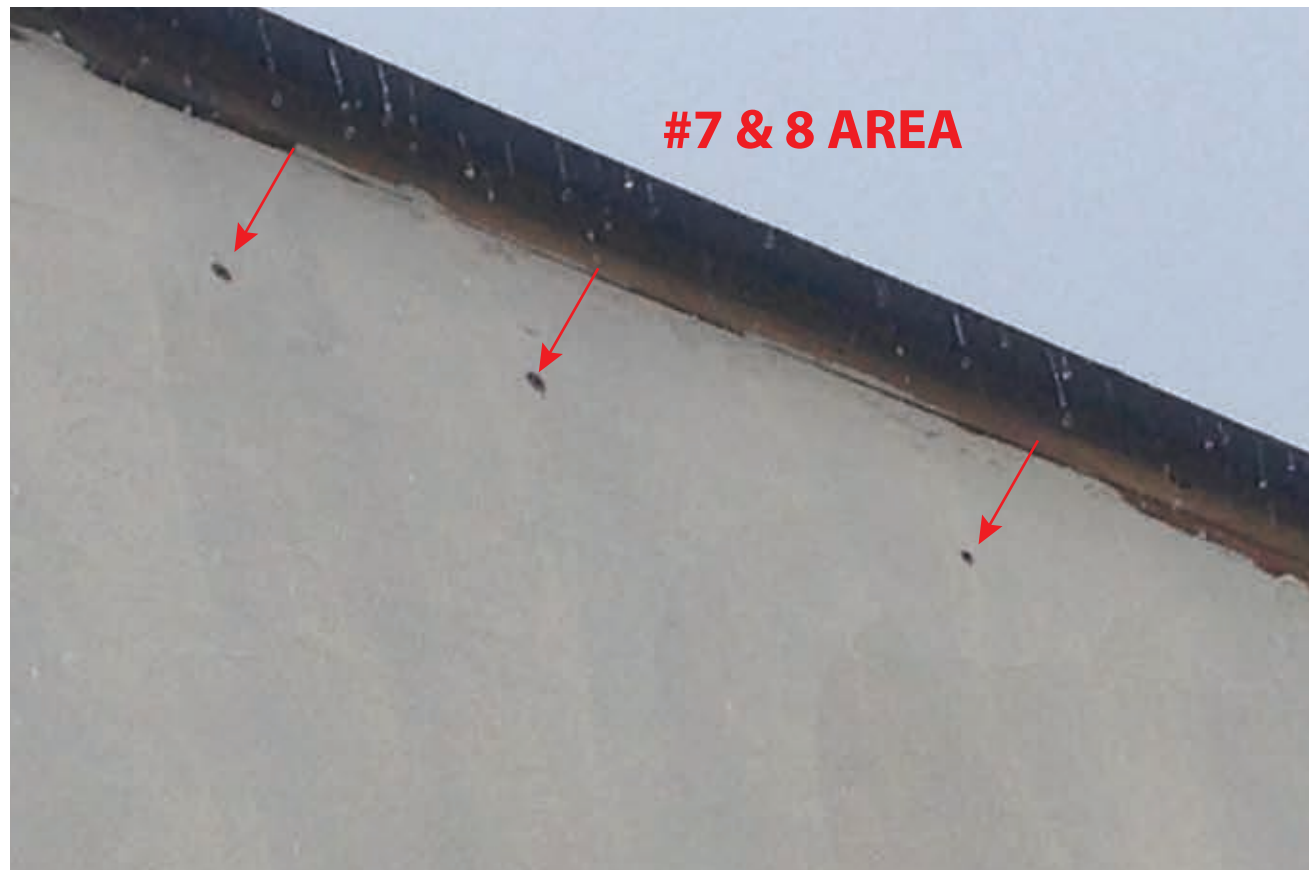
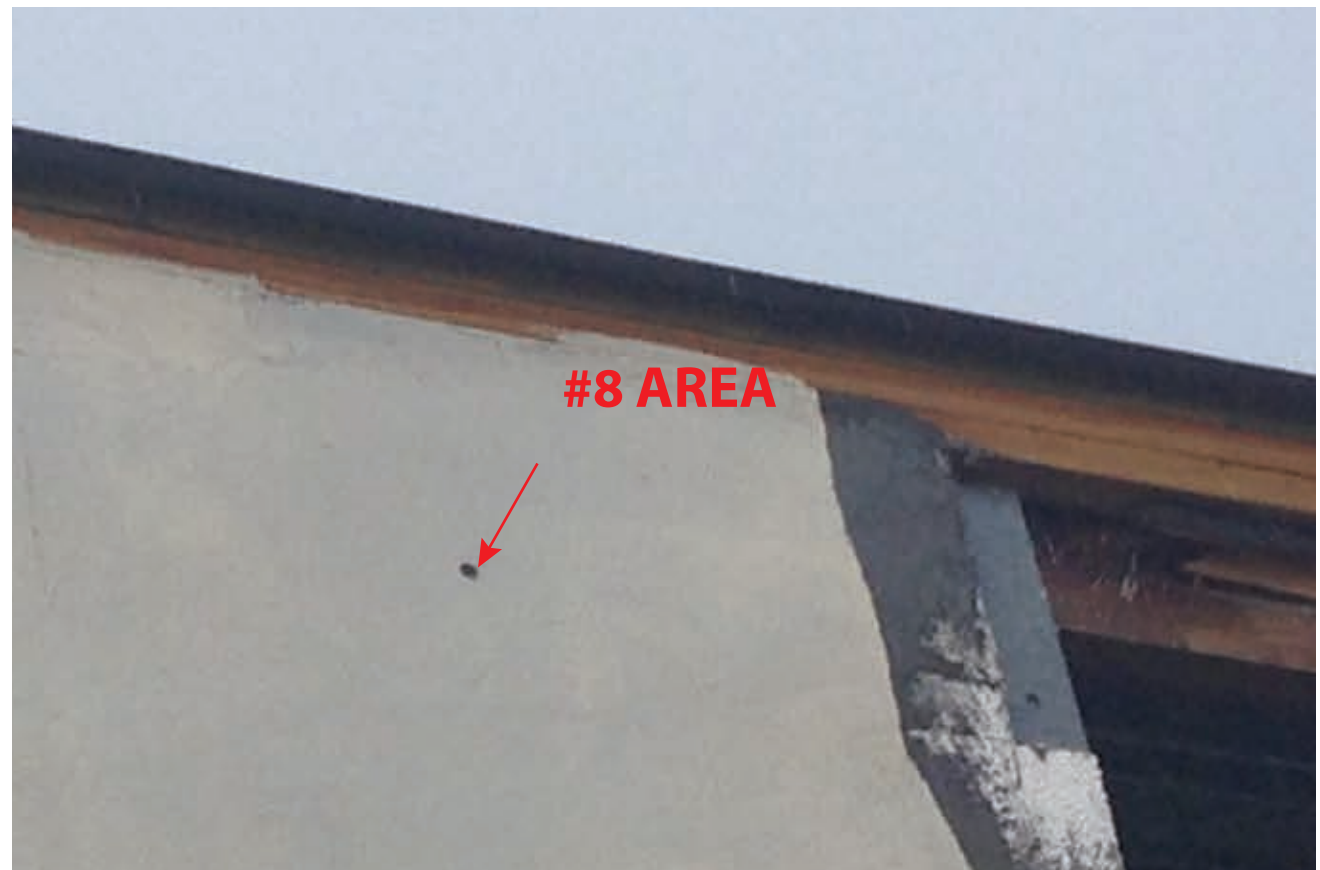
EIFS SYSTEM

ROTTEN WOOD REPAIR

**WATER PROOFING
(GRAY COLOR)**

NOTE THAT THESE ARE OBSERVATION HOLES DRILLED BY THE GC TO DOCUMENT ROTTEN WOOD REPAIRS THAT WERE COVERED BY NEW EIFS

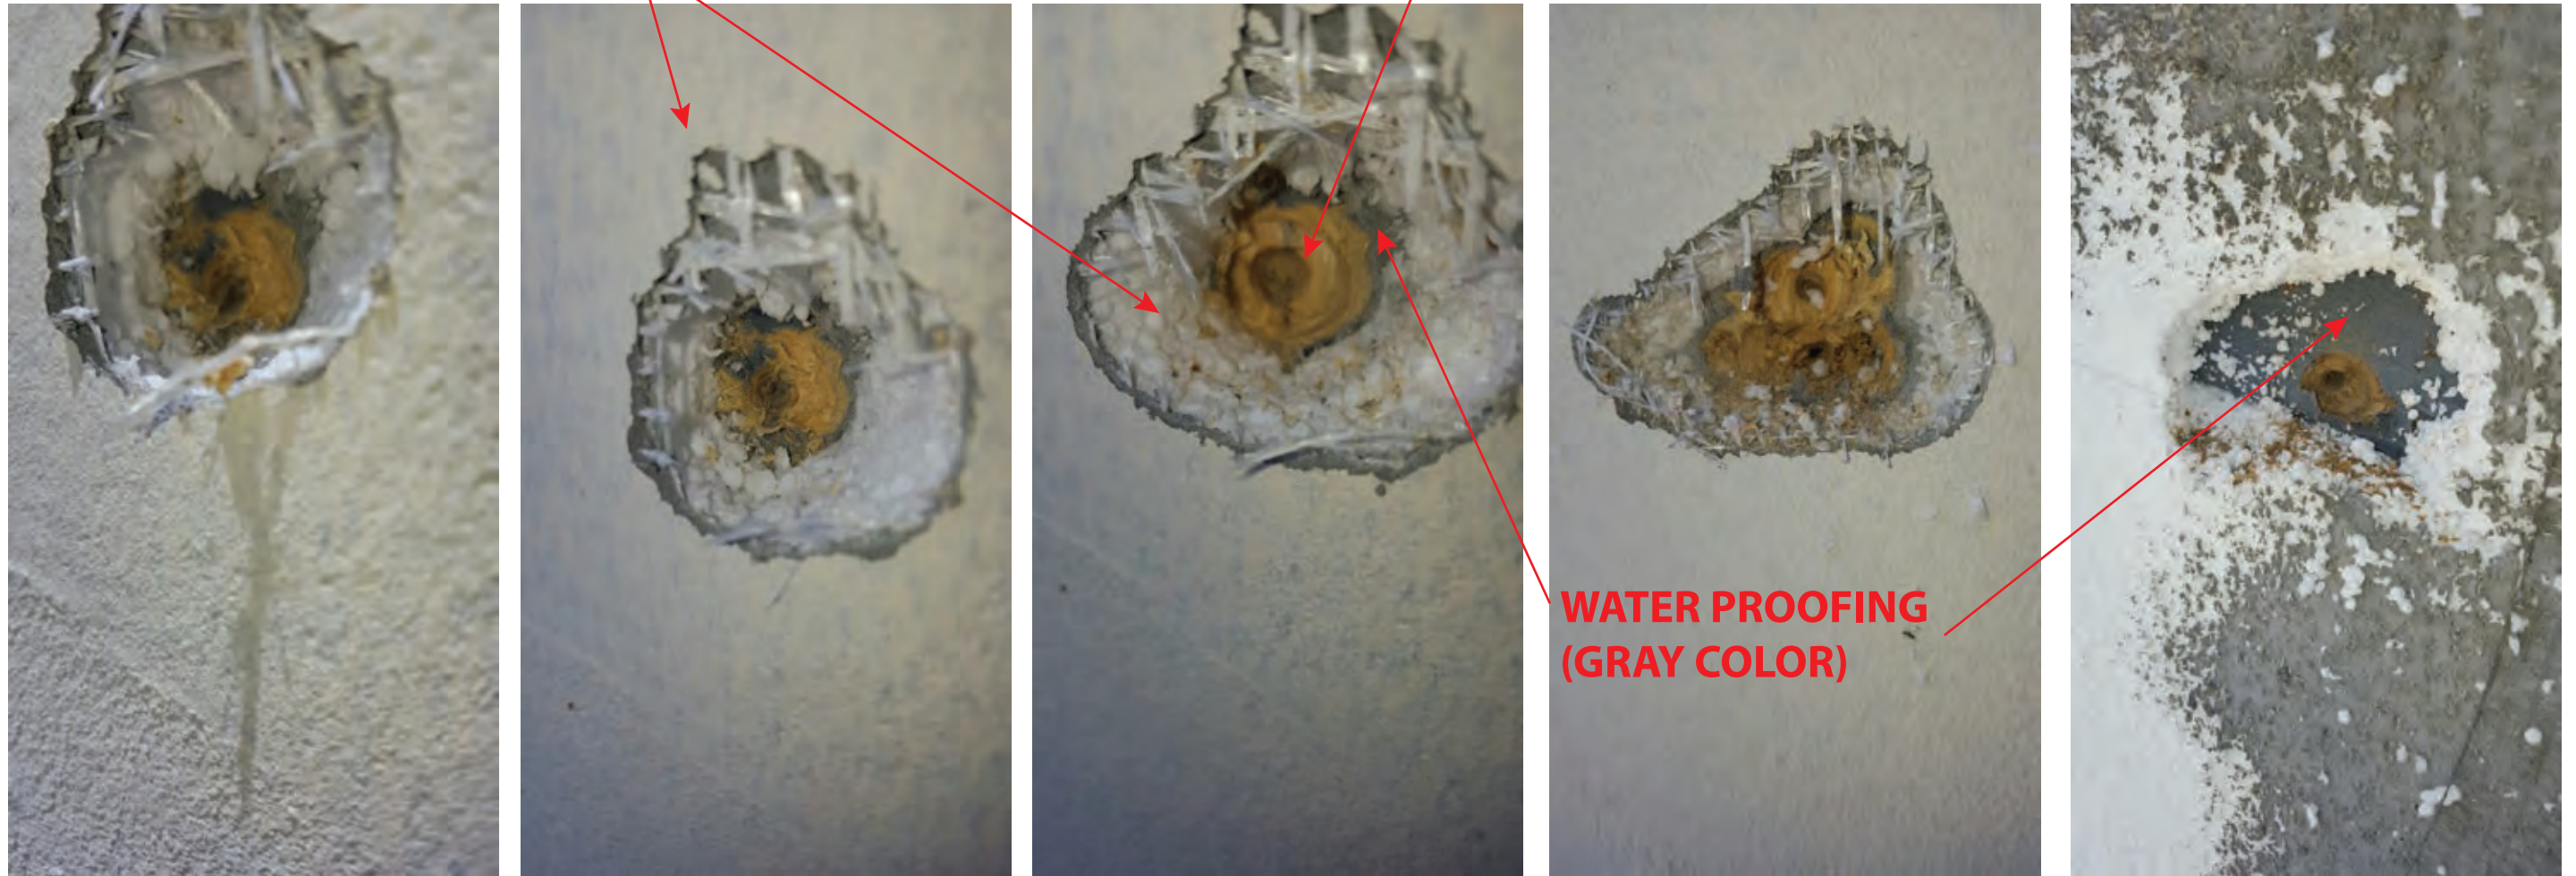
NOTE THAT SCAFFOLDING WORK IS CURRENTLY AT THE FRONT OF THE BUILDING. GC STATED THAT THE REMAINDER OF THE ROTTEN WOOD FACIA AREAS WOULD BE REPLACED AS THE SCAFFOLDING WAS MOVED AROUND THE BUILDING WITH THE EIFS WORK.
